SOME OBSERVATIONS ON THE CONSTRUCTION OF THE M6 MOTORWAY TUNNELS

József Mecsi

University of Pécs, Pollack Mihály Faculty of Engineering and Information Technology
Pécs, Boszorkány u. 2. Hungary 7624

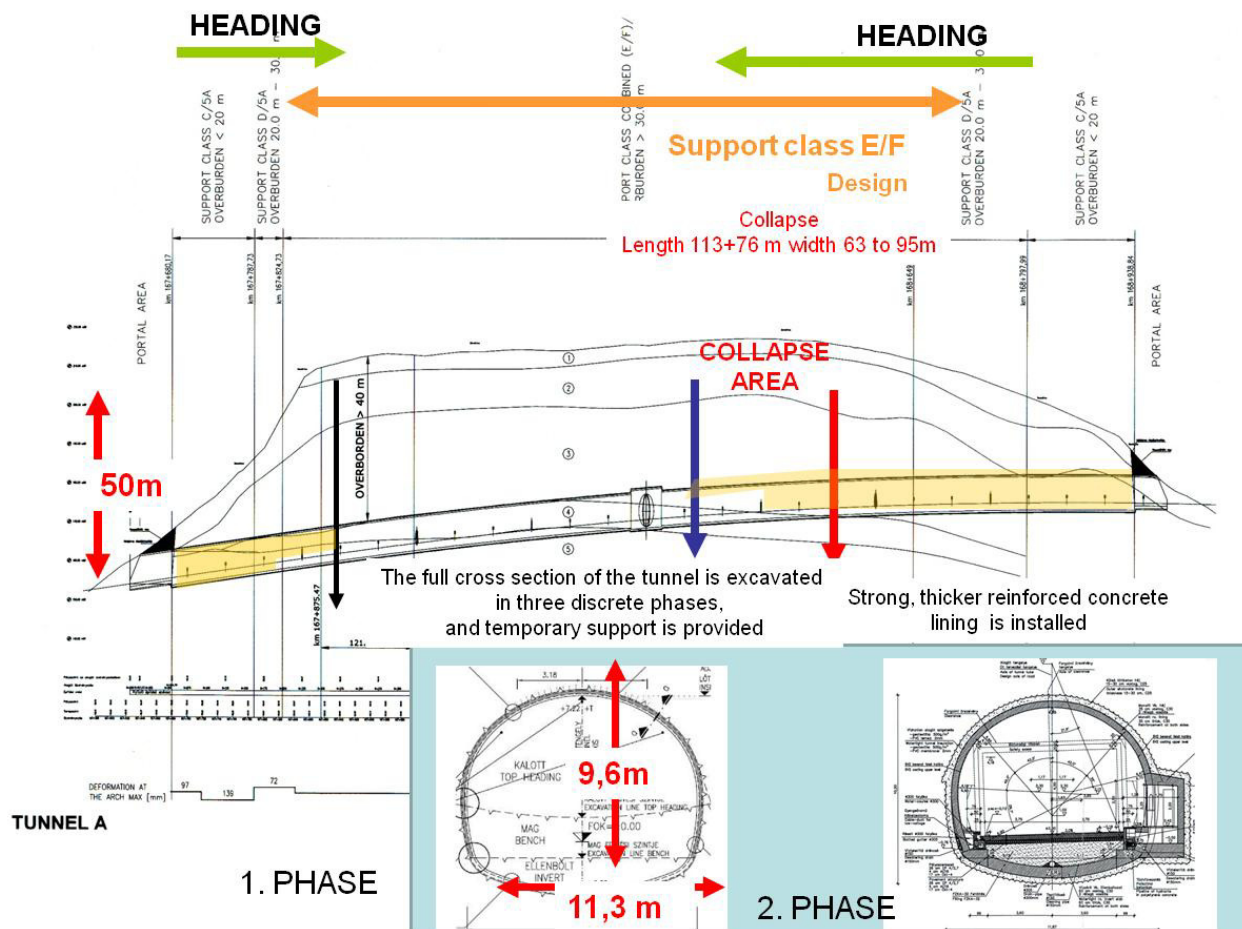
Figure 2

For the purpose of the geotechnical expert opinion initially 29 borings and later further 6 static cone penetration tests (CPTs) were carried out in different depths, the results were analysed and as a result 5 different layers of soil were identified in the soil profile. (Figure 2.)

Longitudinal section of the tunnel with the soil profile and the site plan of the boreholes and the tunnel

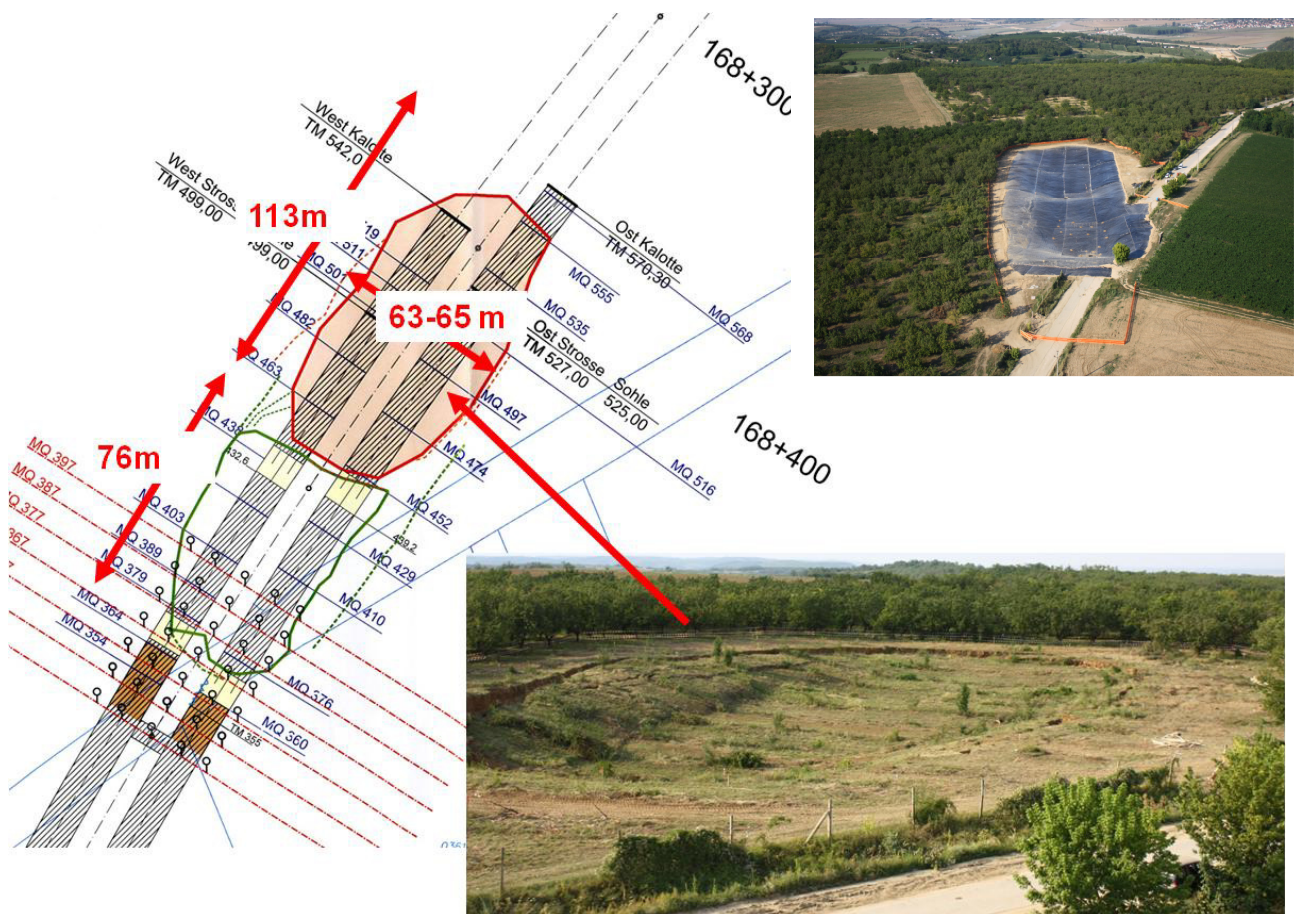
A collapse occurred in Tunnel A affecting the southern side of both tubes at dawn on 24 July 2008. The incidence affected a 120m section of the tunnel in the east tube and 90m in the west tube. The evacuation of the tunnel was successfully completed as the collapse had been preceded by loud cracking noises and visible deformations. The increased air pressure was so high that it knocked down workers waiting at the entrance of the tunnel. Later the incident was followed by further collapse of 80m stretches of the two tubes. According to the first assumptions the two collapses were closely related. Following the incidents work in the four tunnels was stopped and a thorough investigation began to find the contributory causes.

Figure 4 Surface of the collapse area

Safe conditions had to be established for the continuation of the excavation work and the soil to be extracted had to be homogenised while continuously maintaining a specified level of soil strength. Therefore a stabilising row of cemented jet grouting piles was constructed in both tubes of the collapsed section of the tunnel. Stabilisation was started from a depth of 43m in the length of 8m. The minimum designed diameter of the piles was 150cm.

Further excavation in the collapsed section was carried out under the protection of a tube umbrella. The 33 steel tubes with casings were drilled at 45cm intervals into the excavation face, which was supported with concrete, and the voids were grouted. The length of the tube umbrella was 15m and the next tube umbrella section was built in after an excavation length of 10m, therefore there was a 5m overlap between the sections following each other.

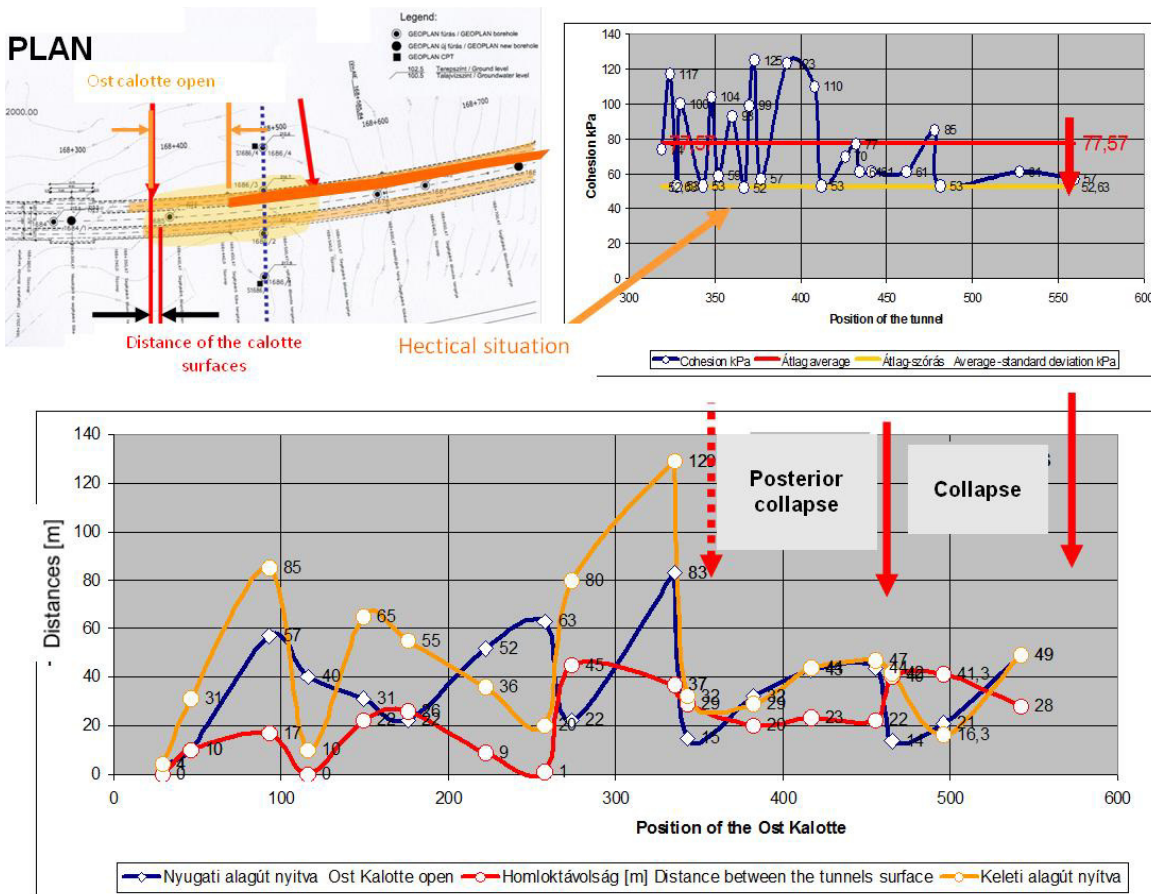
To examine the construction process, a typical cross section of a tunnel construction phase has been selected and is shown on the horizontal axis. (Fig. 6.) The positions of the faces of the other construction phases are shown on the vertical axis. Presenting the distance between the two top heading excavations, the sections of the construction of the benches and the invert, a spatial picture is presented of the tunnel construction. The temporal changes of the selected construction position being also indicated, a clear picture is given of the tunnel construction process advancing in time and space and thus information is obtained as to whether the construction technology was properly applied.

As a result of the analysis it can be presumed that the excavation of the bench and the invert was advancing in the two tubes parallel with each other, more or less in the same section, which is considered unfavourable. Furthermore, the soil excavation of the bench and the invert section was presumably carried out in an unfavourably long segment within a short period of time.

Figure 6. Construction process. Position of the different building position from the Ost kalotte surface [m]

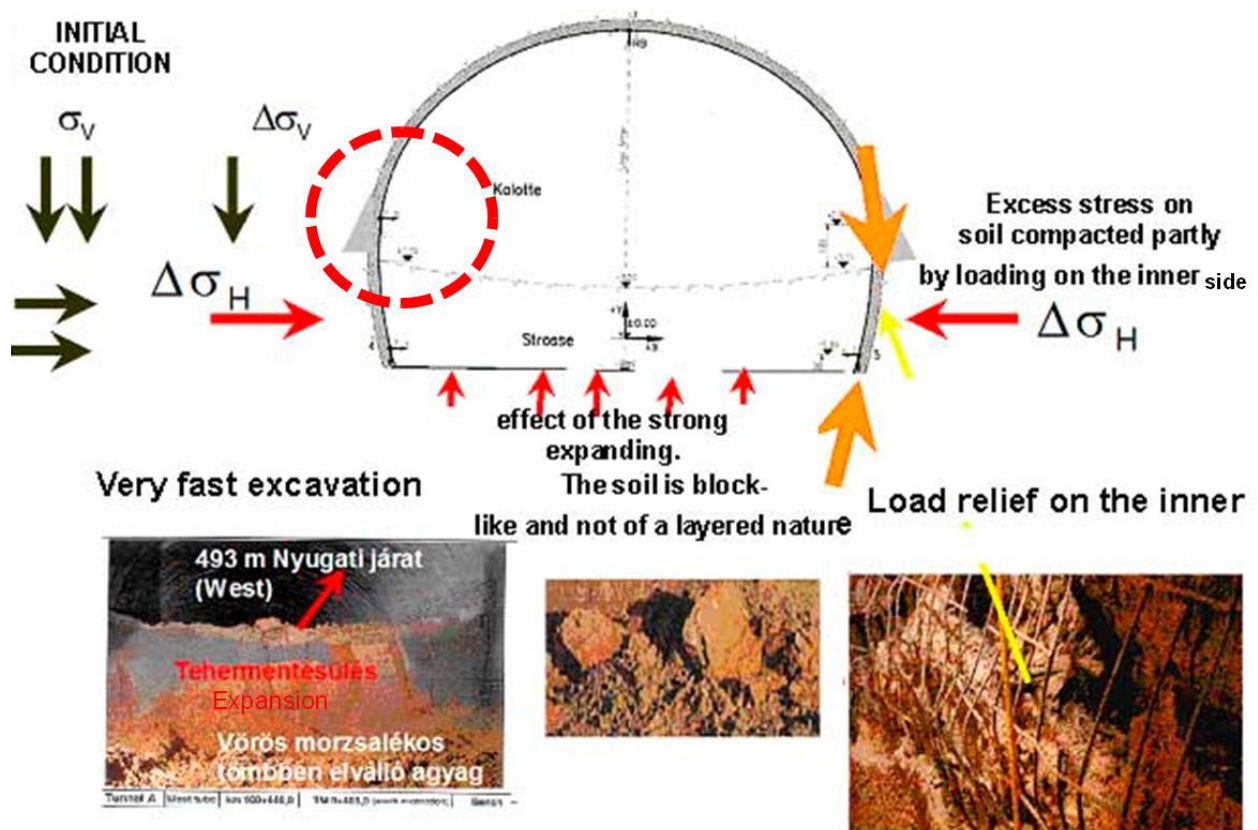
Results of the static tests also confirmed that the most sensitive work phase of the tunnel construction is the excavation of the bench, partly because the excavation of large quantities of soil entails a sudden relief of load, and partly because soil stress redistribution may require more time in clay soil. A large horizontal deformation was visible by the side wall of the tunnel which led to the fracture of the concrete and indicated serious deformations of the tunnel. (Fig. 7.)

It must be noted that along the long tunnel this is the area where soil stratifications proved to be the most unfavourable; the red *Tengelic* clay stratum is situated partly at the bottom of the tunnel and mostly under the tunnel. At other parts of the tunnel the clay stratum is situated either in the whole soil section of the tunnel or deeper under the bottom of the tunnel, therefore the above effect cannot occur or occurs only moderately.

Figure 7 Presumed effect of load relief on clay stratum
