# SOME OBSERVATIONS ON THE CONSTRUCTION OF THE M6 MOTORWAY TUNNELS

József Mecsi

University of Pécs, Pollack Mihály Faculty of Engineering and Information Technology  
Pécs, Boszorkány u. 2. Hungary 7624

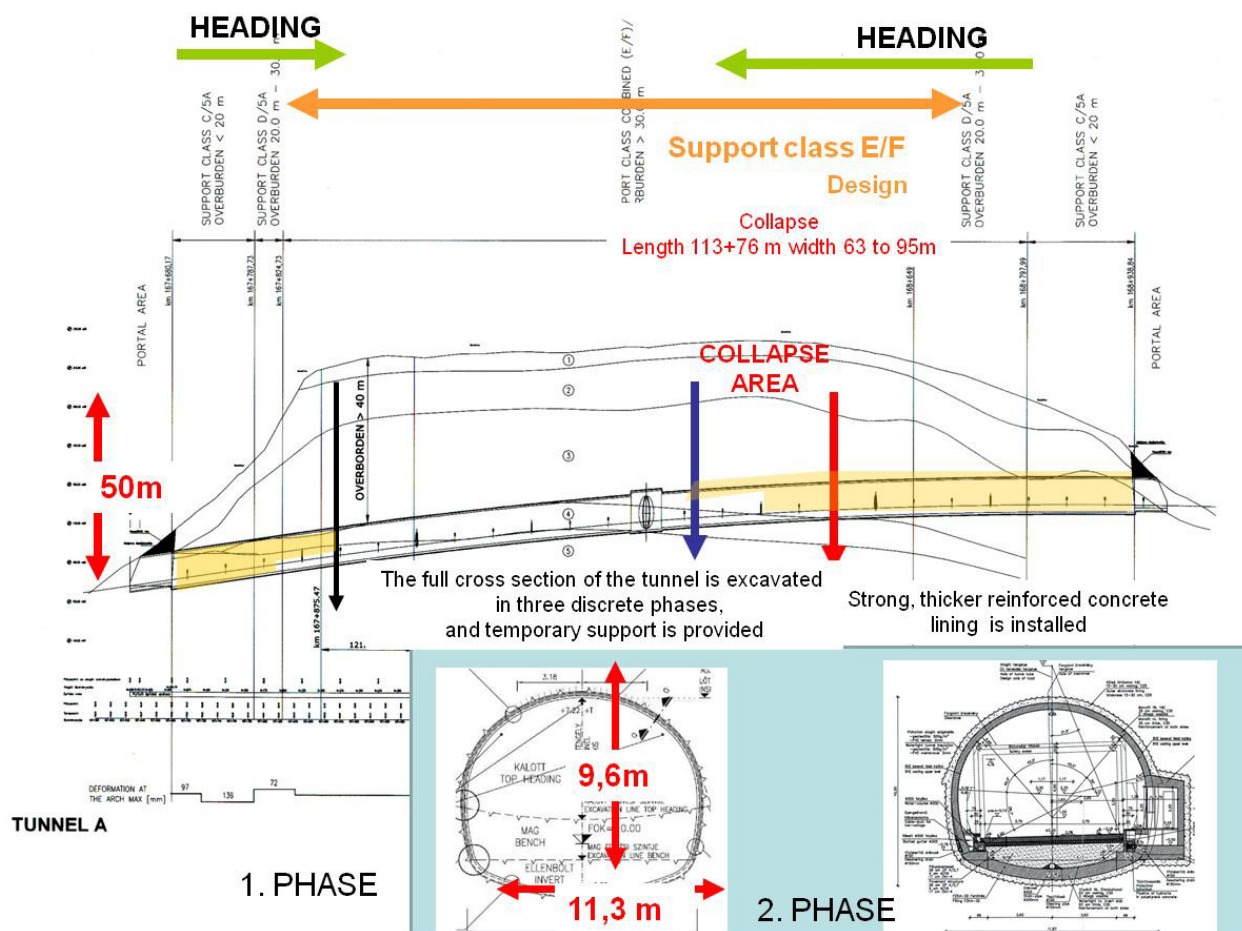
Figure 2

For the purpose of the geotechnical expert opinion initially 29 borings and later further 6 static cone penetration tests (CPTs) were carried out in different depths, the results were analysed and as a result 5 different layers of soil were identified in the soil profile. (Figure 2.) The excavation class for each section was determined on the basis of the penetration test results, extending from Class A to the strictest Class H. The excavation class for each particular section was specified on the basis of the deformation modulus ( $E_s$ ) and cohesion ( $c$ ) of the soil profile and on the basis of the surface soil cover.

Longitudinal section of the tunnel with the soil profile and the site plan of the boreholes and the tunnel

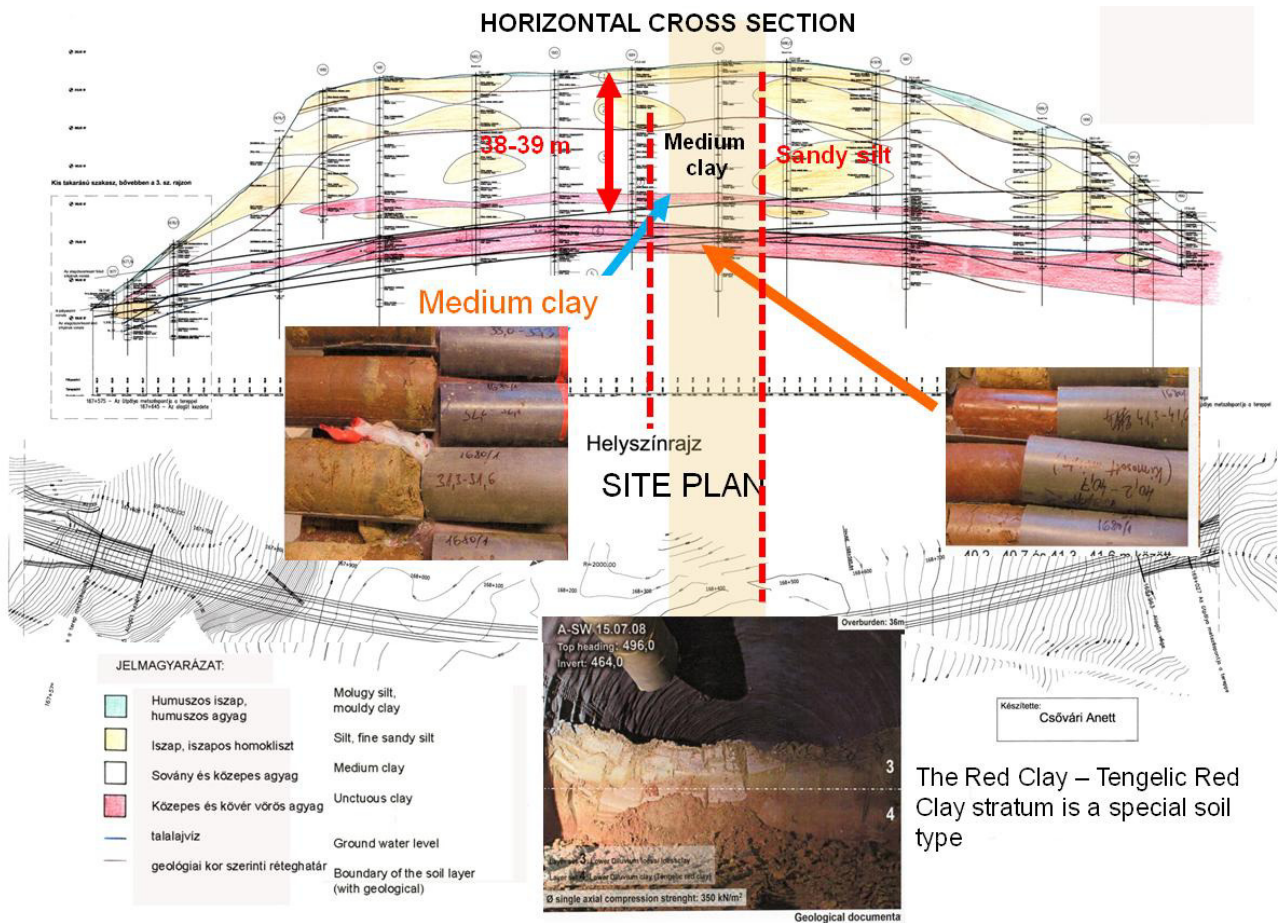
*Figure 3*

The allogenic, weathered variations appear in a depth of 28.7-44.2m in the lower zone of earlier drilled boreholes on the Birka-hill. The allogenic, weathered nature of loess in this area is indicated by clay that formed within the loess beds in an unusually thick layer, by the lime concretion debris („containing limestone”) and, in certain boreholes, gravel intercalations. (Fig.3. )

- Geological descriptions did not indicate loess deposits typical of the area, but heterogenic strata with clay intercalations,
- The slope loess was probably in movement after its geological formation – the clay stratum is not continuously distributed but discontinuously deposited.
- The intercalated red Tengelic clay is of rather unfavourable nature showing volume change behaviour and it is of low shear strength; above and under it are layers of mixed composition soils.
- The high rate of substances of gravel grain size appearing in the strata indicates an unstable geological structure.
- Above the tunnel soil types of higher permeability and of loose structure can be found.
- The soil under the shoulder of the tunnel is of mixed composition, relatively loose and compressible.

*Longitudinal section of the tunnel with the soil profile and the site plan of the boreholes and the tunnel*

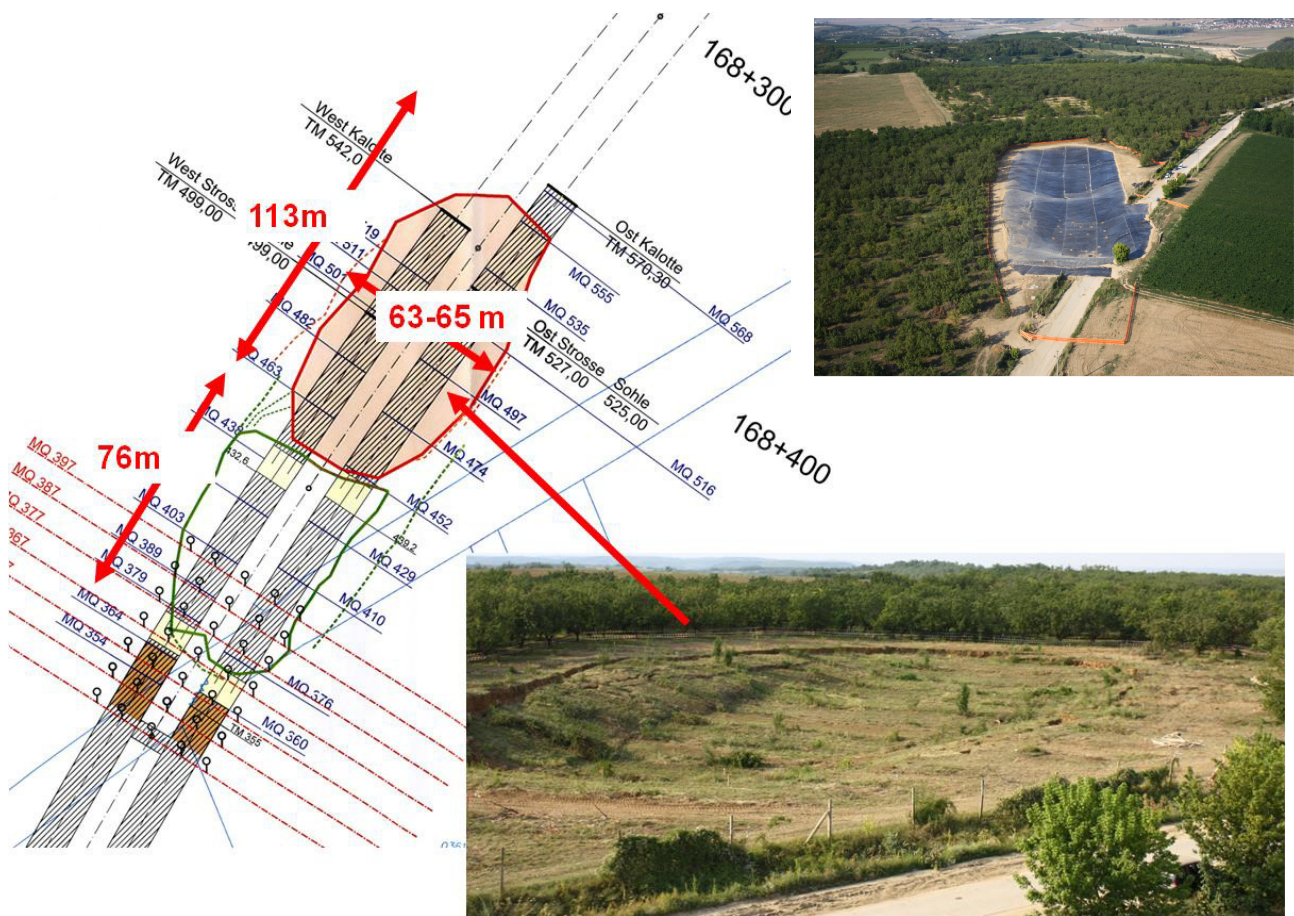
A collapse occurred in Tunnel A affecting the southern side of both tubes at dawn on 24 July 2008. The incidence affected a 120m section of the tunnel in the east tube and 90m in the west tube. The evacuation of the tunnel was successfully completed as the collapse had been preceded by loud cracking noises and visible deformations. The increased air pressure was so high that it knocked down workers waiting at the entrance of the tunnel. Later the incident was followed by further collapse of 80m stretches of the two tubes. According to the first assumptions the two collapses were closely related. Following the incidents work in the four tunnels was stopped and a thorough investigation began to find the contributory causes.

Figure 4 Surface of the collapse area

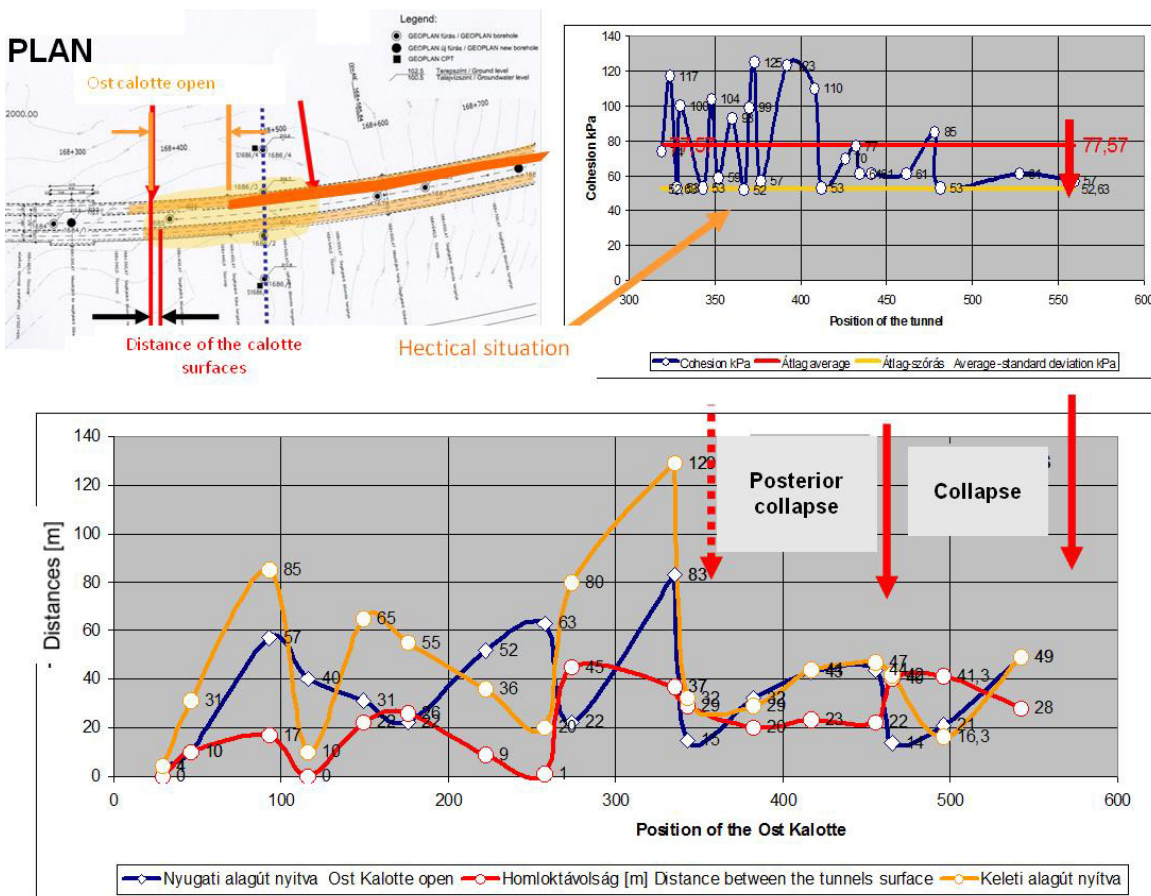
To examine the construction process, a typical cross section of a tunnel construction phase has been selected and is shown on the horizontal axis. (Fig. 6.) The positions of the faces of the other construction phases are shown on the vertical axis. Presenting the distance between the two top heading excavations, the sections of the construction of the benches and the invert, a spatial picture is presented of the tunnel construction. The temporal changes of the selected construction position being also indicated, a clear picture is given of the tunnel construction process advancing in time and space and thus information is obtained as to whether the construction technology was properly applied.

As a result of the analysis it can be presumed that the excavation of the bench and the invert was advancing in the two tubes parallel with each other, more or less in the same section, which is considered unfavourable. Furthermore, the soil excavation of the bench and the invert section was presumably carried out in an unfavourably long segment within a short period of time.

The effects of the soil excavation and the unfavourable geological conditions were further strengthened by the weakness of the tunnel sealing.

Figure 6. Construction process. Position of the different building position from the Ost kalotte surface [m]

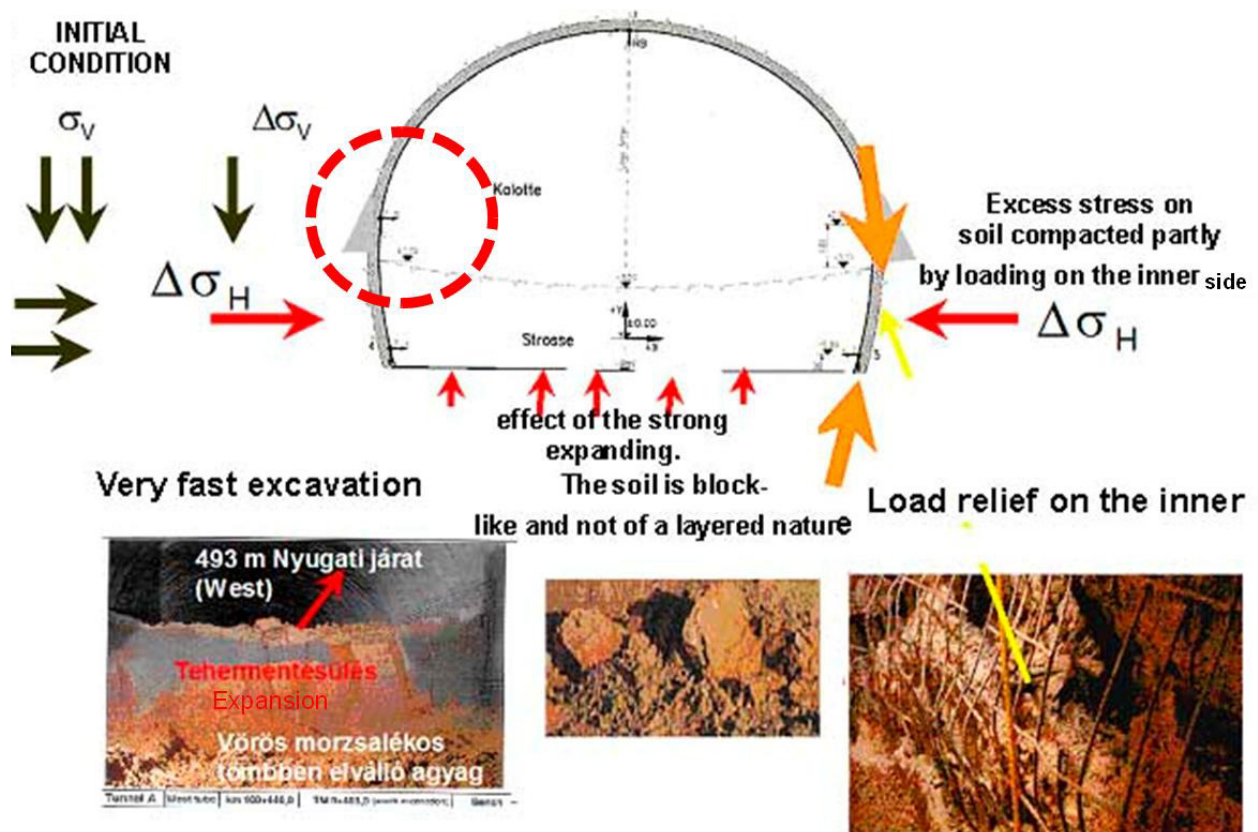
Results of the static tests also confirmed that the most sensitive work phase of the tunnel construction is the excavation of the bench, partly because the excavation of large quantities of soil entails a sudden relief of load, and partly because soil stress redistribution may require more time in clay soil. A large horizontal deformation was visible by the side wall of the tunnel which led to the fracture of the concrete and indicated serious deformations of the tunnel. (Fig. 7.)

It must be noted that along the long tunnel this is the area where soil stratifications proved to be the most unfavourable; the red *Tengelic* clay stratum is situated partly at the bottom of the tunnel and mostly under the tunnel. At other parts of the tunnel the clay stratum is situated either in the whole soil section of the tunnel or deeper under the bottom of the tunnel, therefore the above effect cannot occur or occurs only moderately.

Figure 7 Presumed effect of load relief on clay stratum
