The Use of Hard Rock TBMs in Turkey
Cutting Mechanism, Selection, Applications ,Problems

Hungarian Tunnelling Society
7th November 2011

Prof.Dr.Nuh Bilgin
bilgin@itu.edu.tr

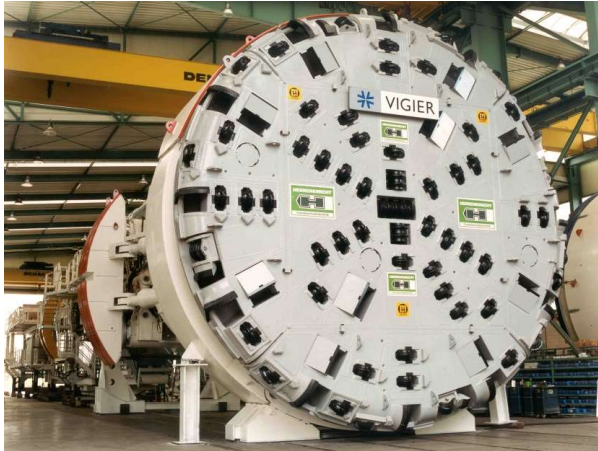
Tunnel Boring Machines Using Disc Cutters

Single Gripper-TBM:

Double Gripper-TBM:

Single Shield TBM

Double Shield-TBM:

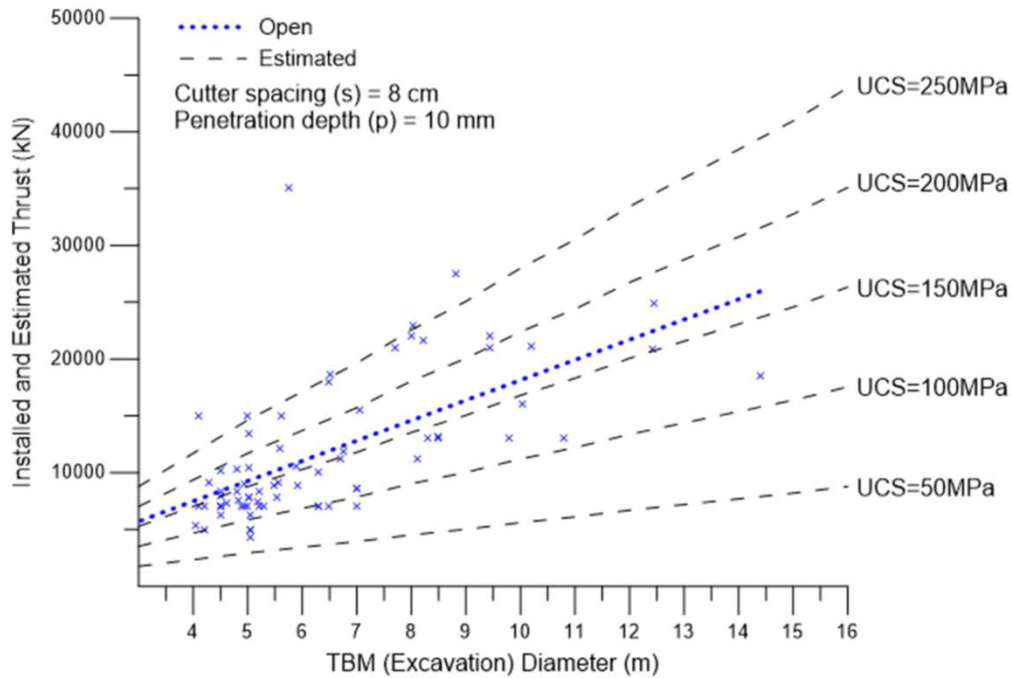
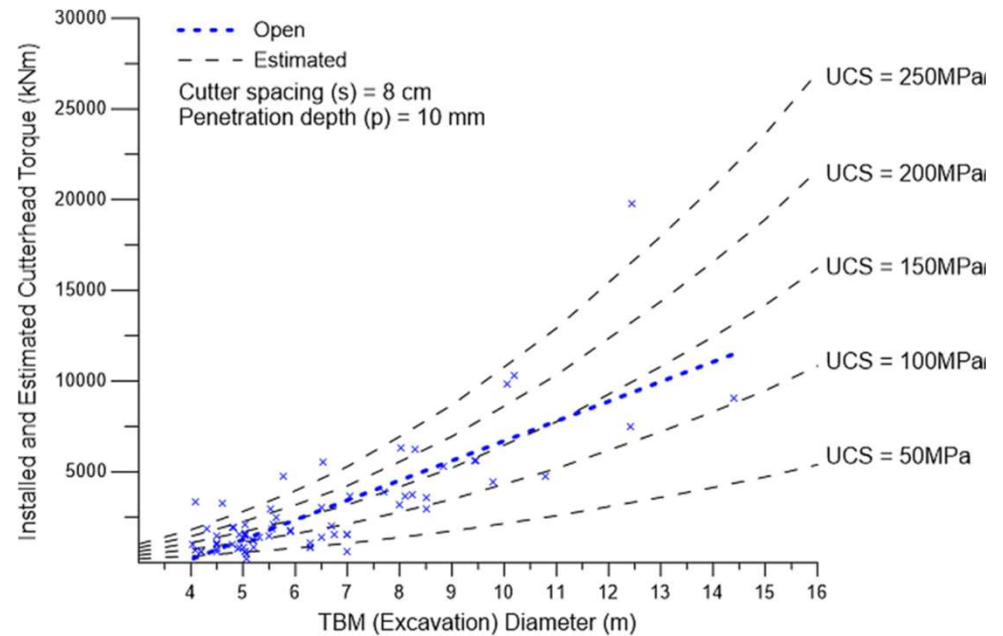
Estimation of Thrust and Torque of Gripper type TBM's

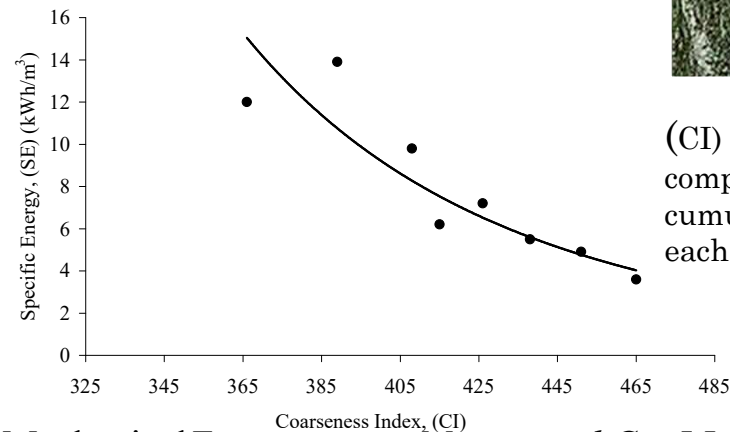
Cutting Mechanism of Disc Cutters

(CI) is a non – dimensional number used for comparison of muck size. It is the sum of the cumulative weight percentages retained in each sieve used.

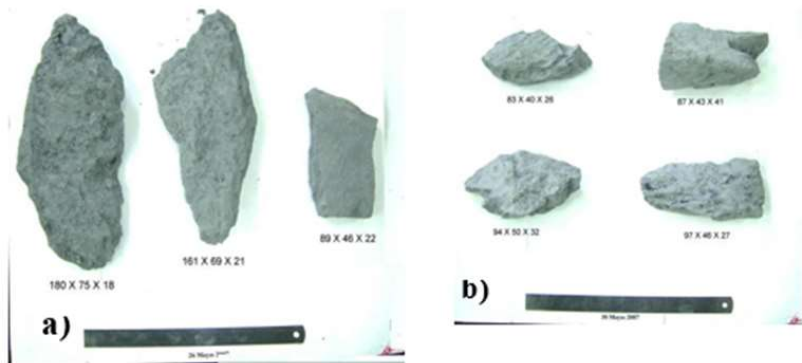
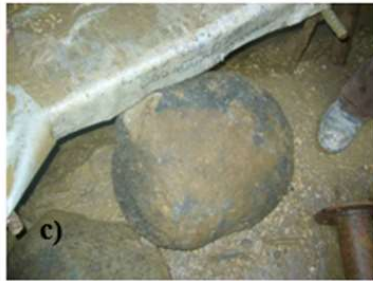
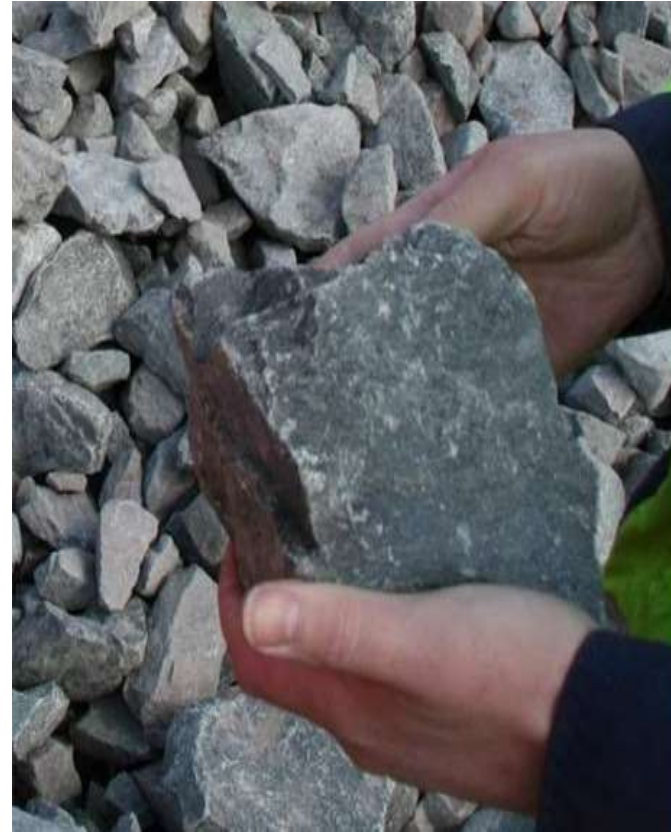
The size of muck is related to geology and is a function of cutting efficiency

a) Chip formation in massive limestone b) Chip formation in fractured zone

c) Big pebbles in Alluvion

d) Muck in mudstone.

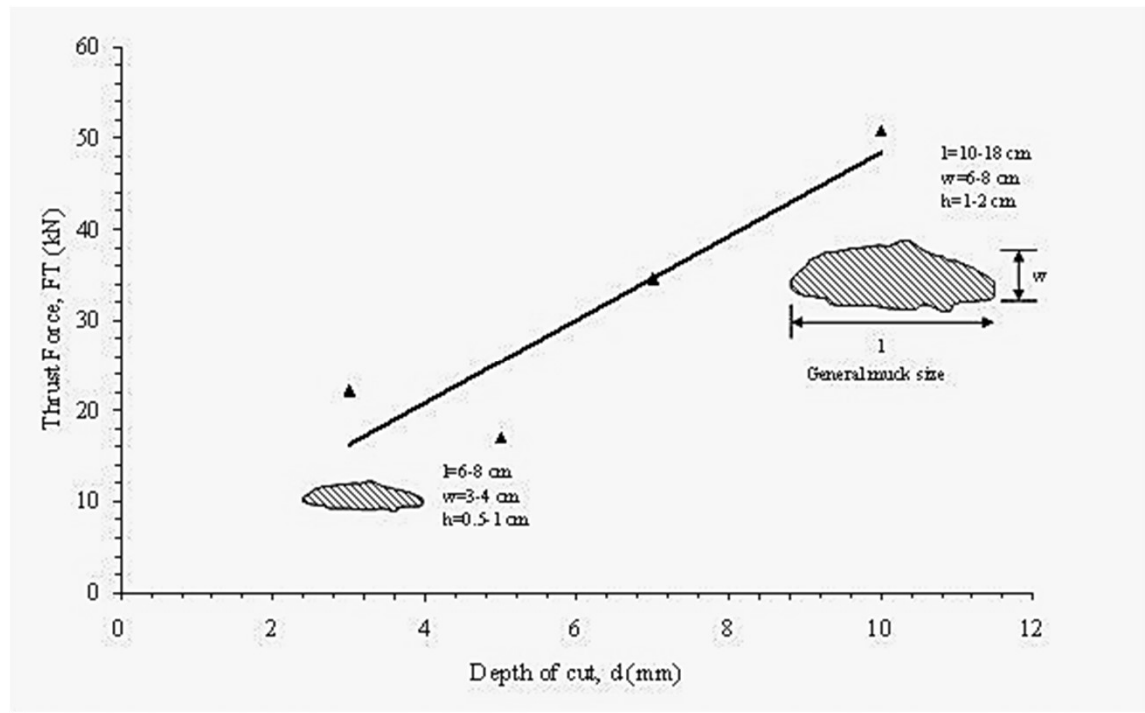
There is a relation between muck size, thrust force and cutting efficiency

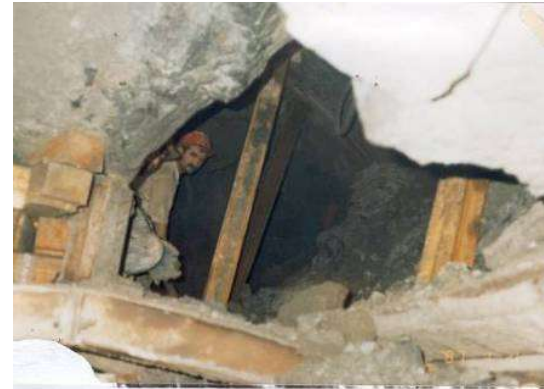
The First TBM used in Istanbul 1984 Baltalimanı Sewerage Tunnel in very fractured rock. Lessons Learned : Never use griper TBM in highly fractured rock formation

The collapses occurred upon the tunnel

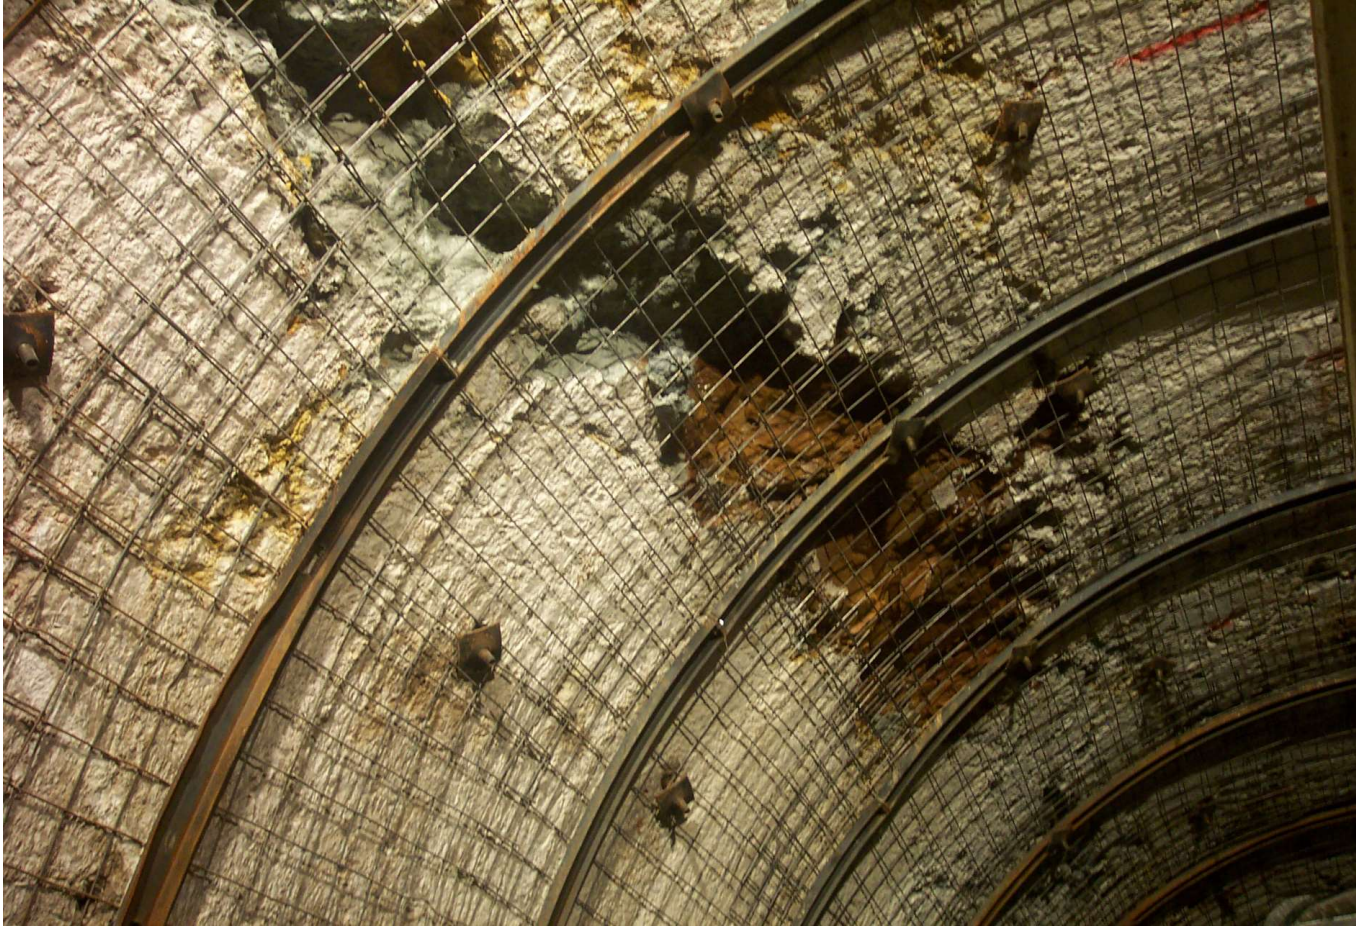
Tunnel Support in Ermenek Tunnel with Gripper Type TBM

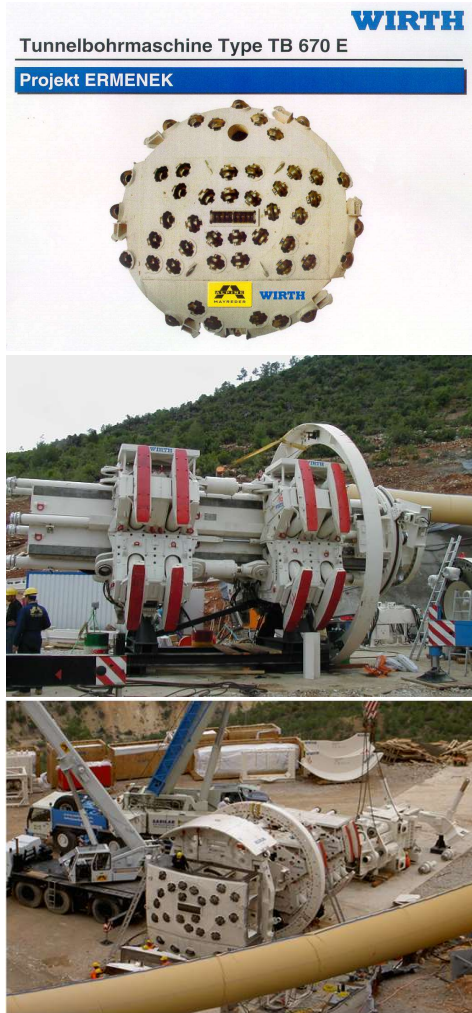
Ermenek Power Tunnel

TBM	WIRTH (Now Creg)
D	6.7 m
Discs No	52
Disc Diam.	432 mm
Power	1800 kW
Rotation	0-8.1 rpm
Torque	2020 kNm
Thrust	9600 kN

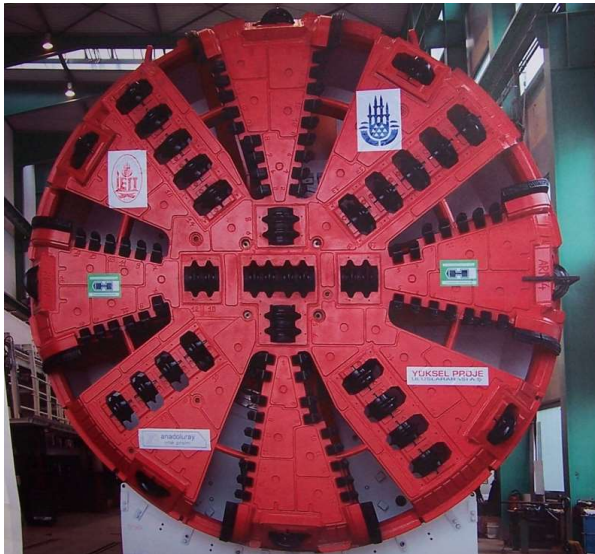
Single Shield TBM in Fractured Rock, in Kozyatağı Kadıköy Metro Tunnel

- In the contact zone between Trakya Formation and Dyke, and in very fracture face collapses may occur, In these cases the openings in front of TBM should be reduced. Typical examples, Kadıköy –Kartal , Metro tunnel, Marmaray Project, Beykoz sewerage tunnel, Kargı hess tunnel, Köseköy Tunnel

TBM Diameter	6.57 m
Number of discs	26 single + 6 twins (12) = 38
Max. Disc Capacity	267 kN
“ Main bearing” capacity	20,000 kN static
Cutting Head Power	1,260 kW (4x315)
Rotational speed	1.6-5.5 rpm
Cutting Head Torque	5,200 kNm at 1.6 rpm
	1,515 kNm at 5.5 rpm
Thrut capacity	42575 kN at 350 bar

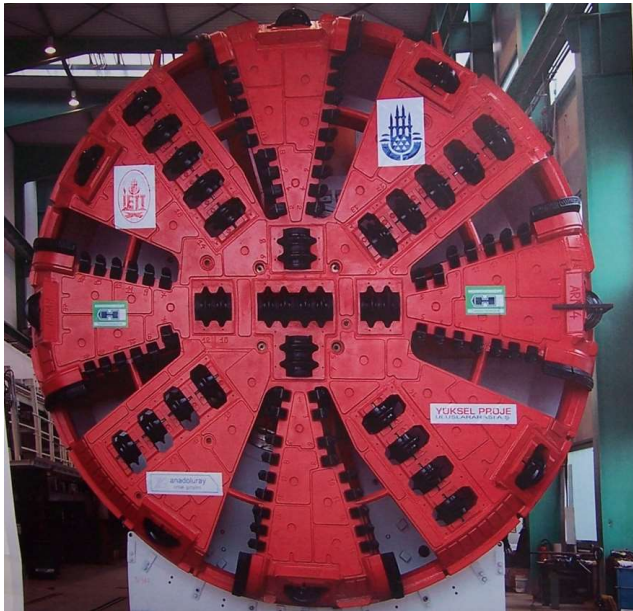
Putting Grizzly Bars to Stop Tunnel Face Collapses

Initial cutting head

Grizzly bars were added to the openings to stop face collapses. Around the same date such precautions were taken in Marmaray and Beykoz tunnels

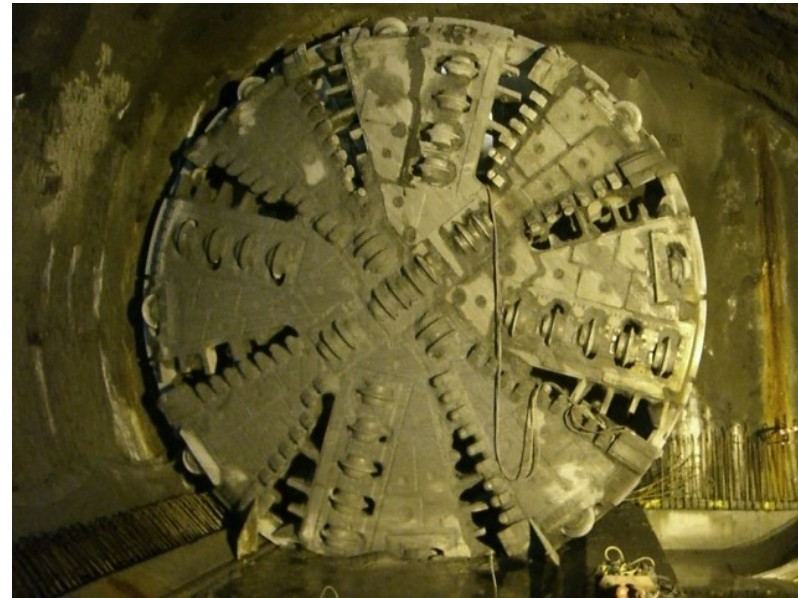
TBM-360 cutting head with grizzly bars

From 7th September till 15th April mean daily advance increased to 8.48m.

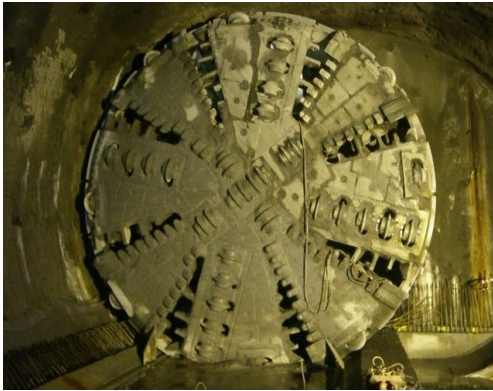
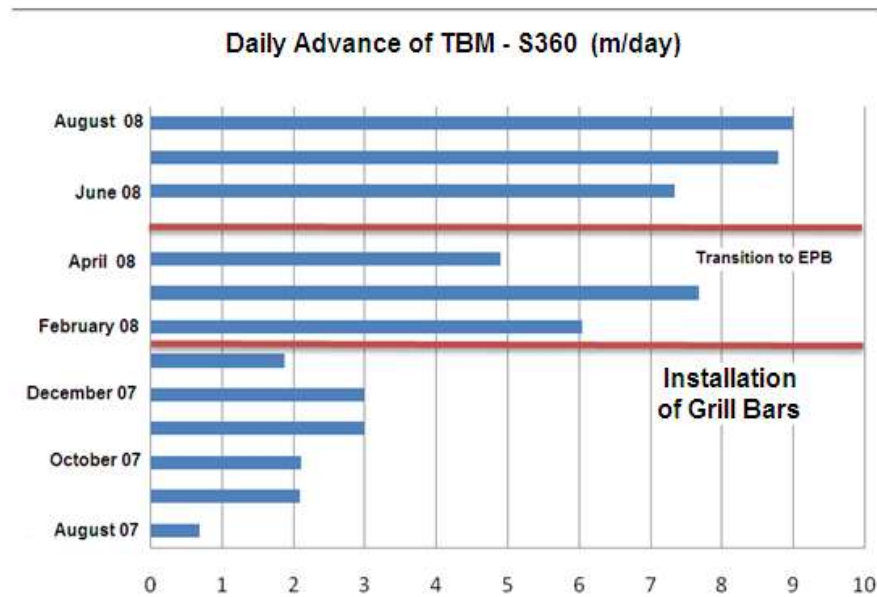
The Effect of Putting grizzly on Bars and Changing to Closed Mode (EPB) from Open Mode

Putting grizzly bars on cutterhead

Aug 07	Sep 07	Oct 07	Nov 07	Dec 07	Jan 08	Feb 08	Mar 08	Apr 08	May 08	Jun 08	Jul 08	Aug 08
0,7	2,1	2,1	3	3	1,9	6,1	7,7	4,9	0	7,4	8,8	9
m/gün

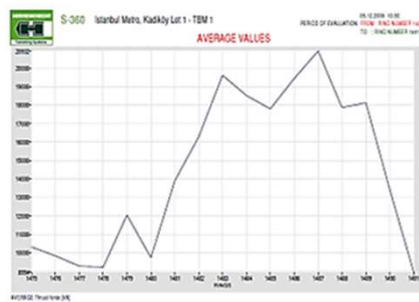
The increase of thrust force due to stalling of disc cutters in blocky ground.

In November 2008, during the excavation of Goztepe-Kadikoy Metro tunnel with a 6.6 m EPB TBM in blocky sandstone it was reported that thrust force started increasing from 10000 kN in ring 1480 and thrust increased gradually up to ring 19860 kN, however, this was reverse for torque decreasing from 2.7 MNm down to 1.6 within the same rings. This phenomenon is illustrated in the following Figures.. This is typical behavior of chisel cutters or rippers where the cutting force (equivalent to torque) is less than normal force (or thrust) in most cases. The operation was stopped to check the cutterhead. It was noticed that 6 center double discs and 4 single discs were flattened as seen in Figure 9 and one disc were destroyed completely. The careful observation of checking the change in thrust and torque values of TBM prevented demolishing the cutterhead.

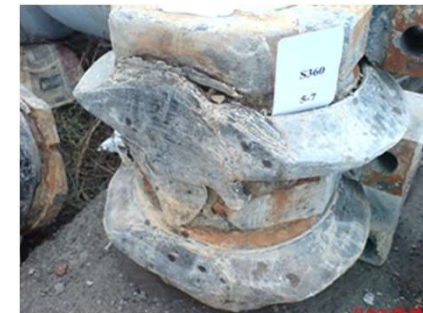
Figure. The wear of twin disc cutter due of stalling disc cutter in blocky ground.

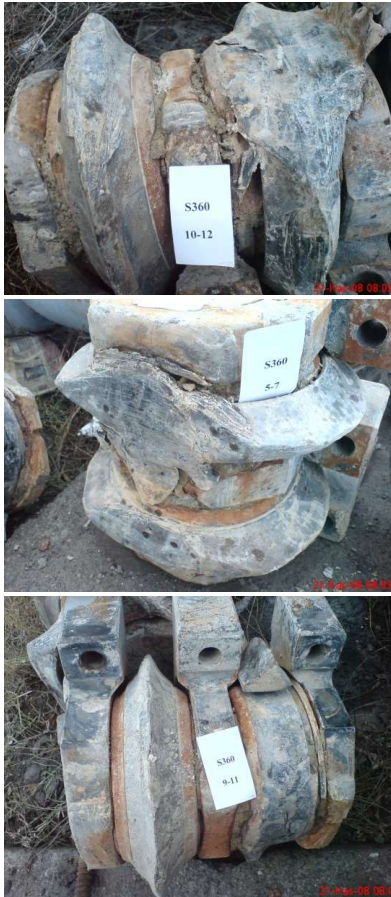
The Effect of Big Blocks on Disc Blockage

Failure of discs between 1480-1491 rings due a fault zone

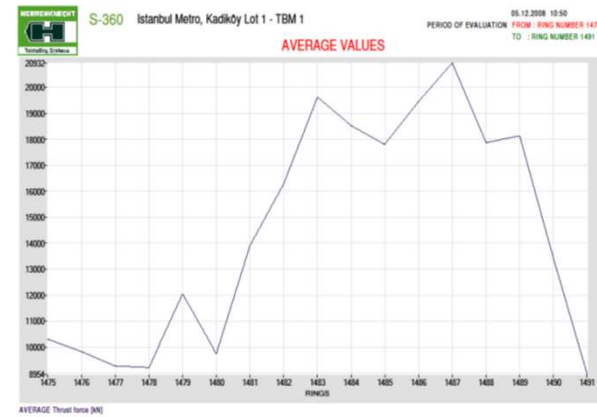
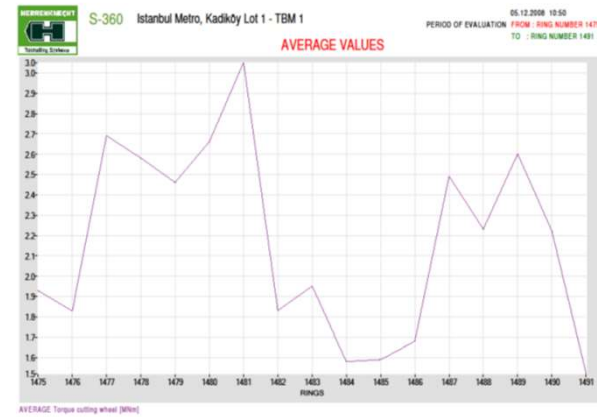
The variation of thrust and torque with rings 1480-1491

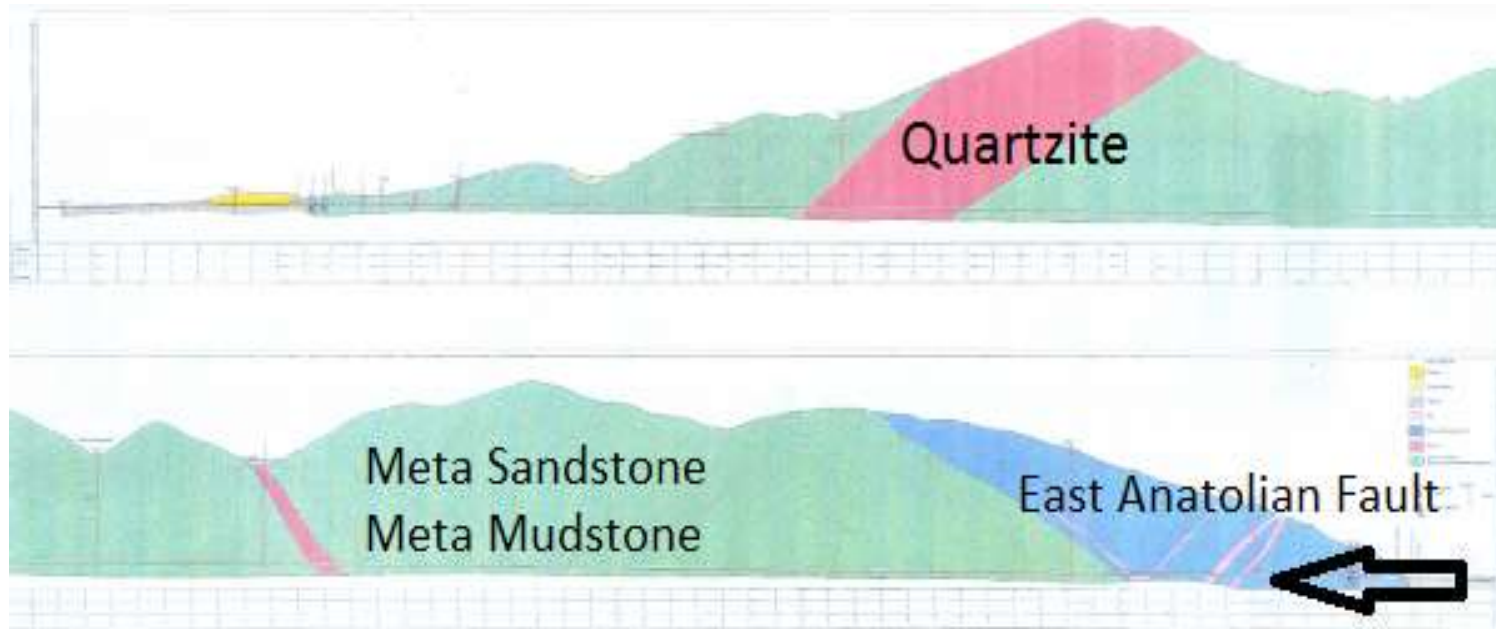
The Geology of Nurdağı Tunnel

The length of the two tubes railway tunnel is 9750 m and diameter is 8 m. It was decided to open the first 1000 m of the tunnel by NATM since the tunnel was under the influence of East Anatolian Fault.

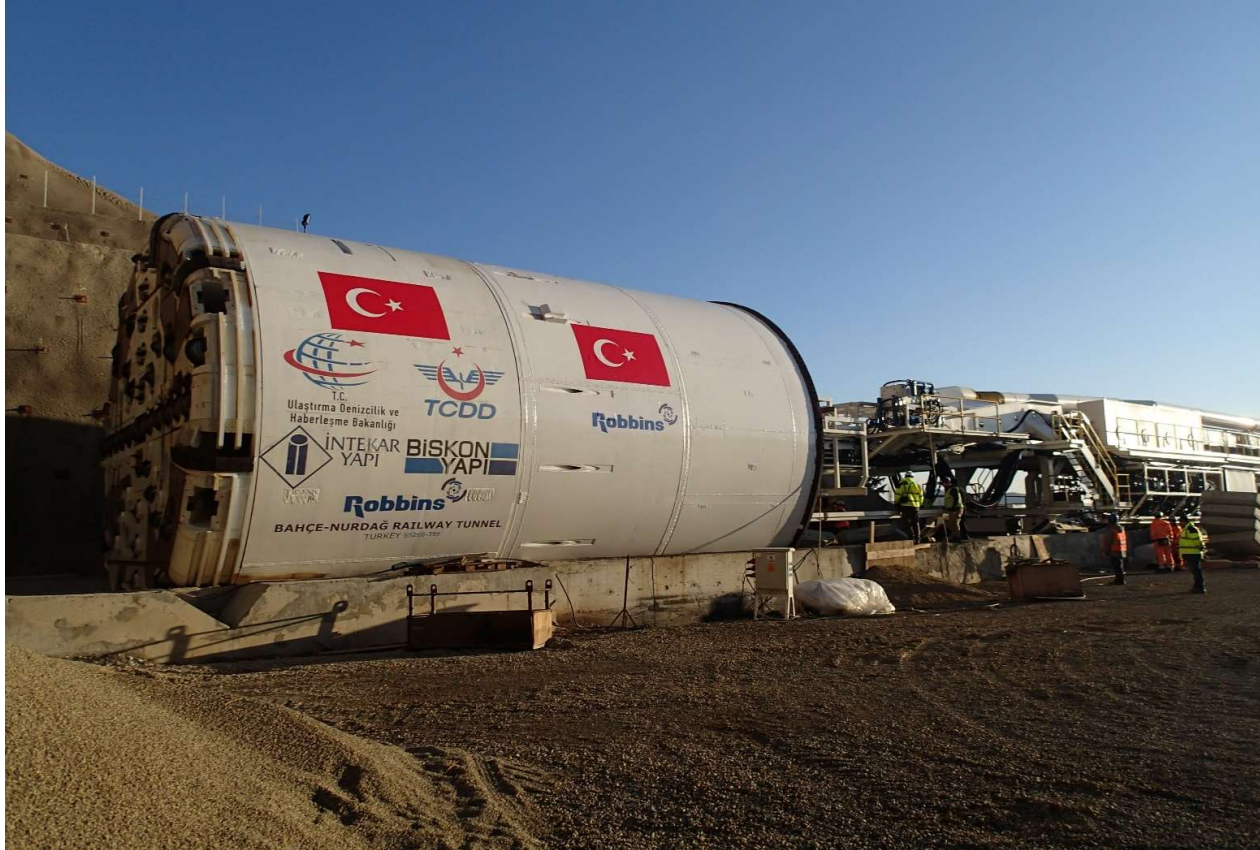
Single Shield TBM used in Nurdađı Tunnel, Robbins TBM SS268-398

Technical Specification of High Performance Single Shield Robbins Hard Rock TBM SS268-398

TBM diameter	8 m
Number of buckets	8
Over cut	40 mm on radius
Number of disc cutters	53x19"
Maximum disc load	3111 kN
Average cutter spacing	77.6 mm
Cutterhead torque	9,635 kNm at 0-3.3 rpm
Exceptional torque	14,453 kNm at 0.33 rpm
Recommended max. thrust	16,500 kN
Cutterhead total power	10X330 kW

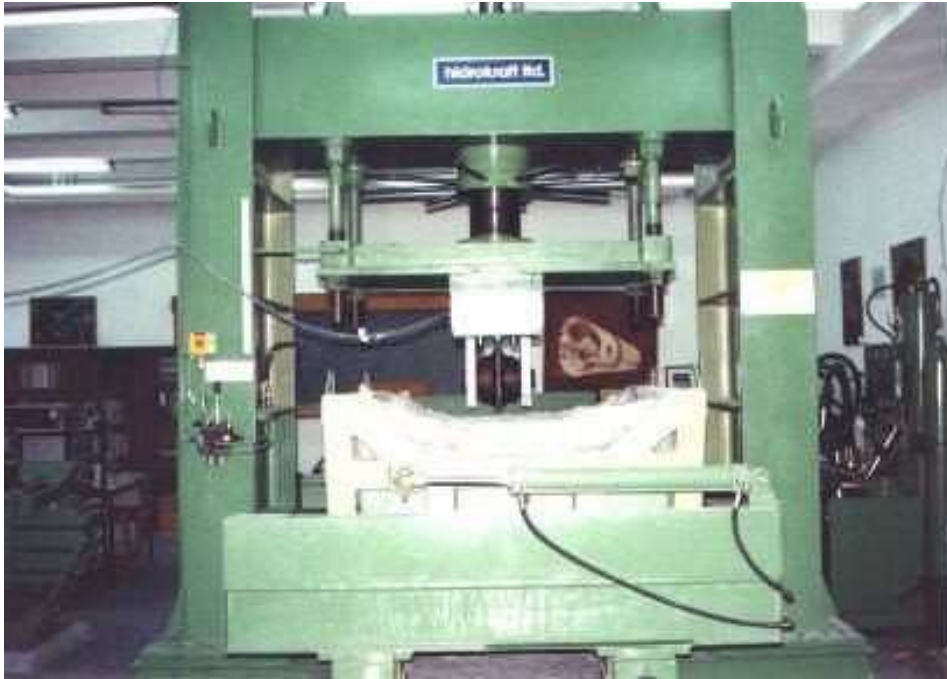
Specifications of TBM in Nurdağı Tunnel Were Decided after Full Laboratory Cutting Experiments

Specific Energy Obtained in the Laboratory for Relieved and Unrelieved Cutting Experiments

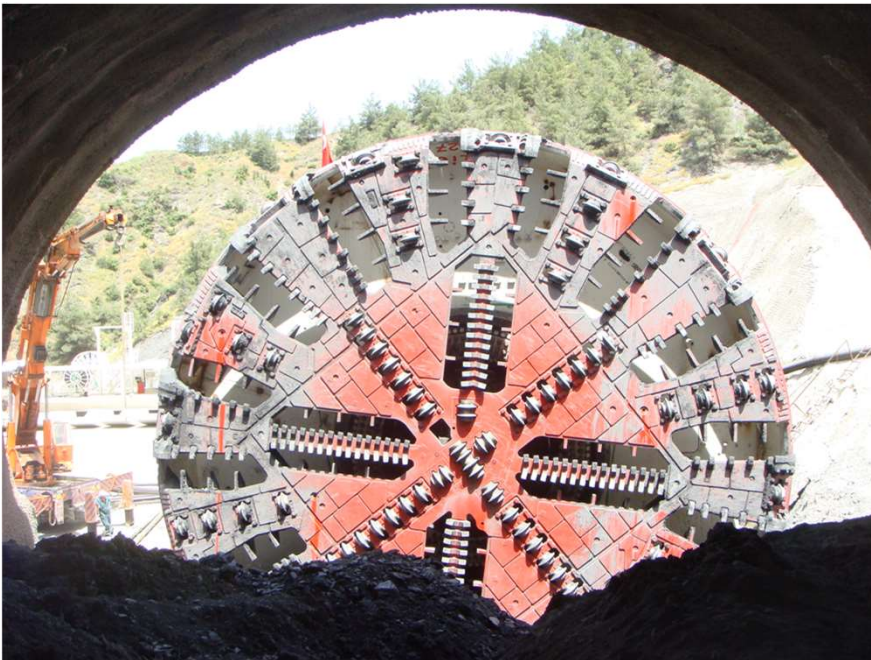
Problems in Graphitic Shists with a Single Shield TBM in Köseköy High Speed Tunnel

Mixed ground conditions with **ophiolites, graphitic schists** and mélanges with boulders including over excavation were the main difficulties leading to squeezing and blocking of the TBMs or even **causing complete failures of the segments and abandoning of the tunnel. Remedial works** are sometimes complex and tedious :**reducing the size of openings, minimal waiting, control of over excavation, lubrication between shield and rock, umbrella arch, increasing torque and thrust and sometimes rescue galleries are necessary.**

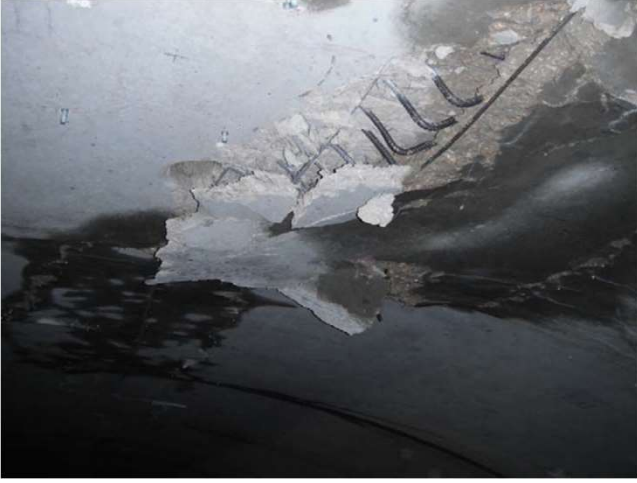
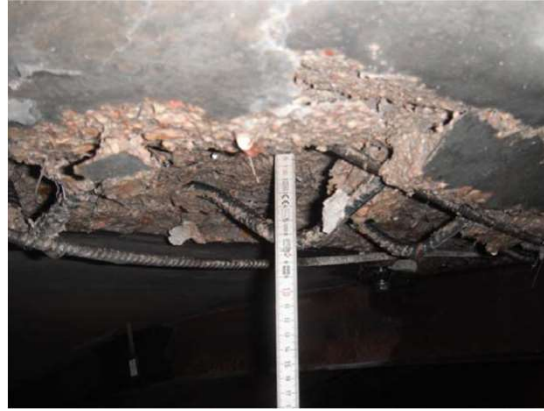
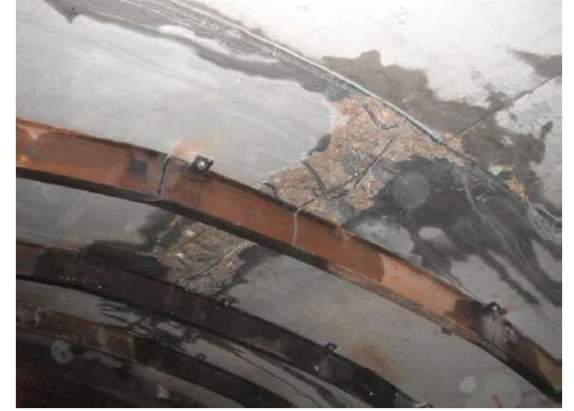
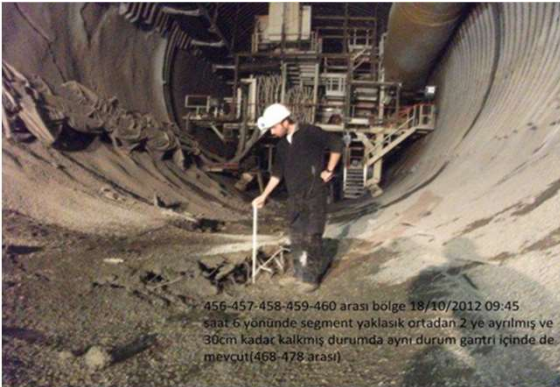
The Collapse of Segments and Tunnel in Köseköy Tunnel

456-457-458-459-460 arası bölge 18/10/2012 09-45
Saat 6 yönünde segment yaklaşık ortadan 2 ye ayrılmış ve
30cm kadar kalkmış durumda aynı durum gantri içinde de
mevcut(468-478 arası)

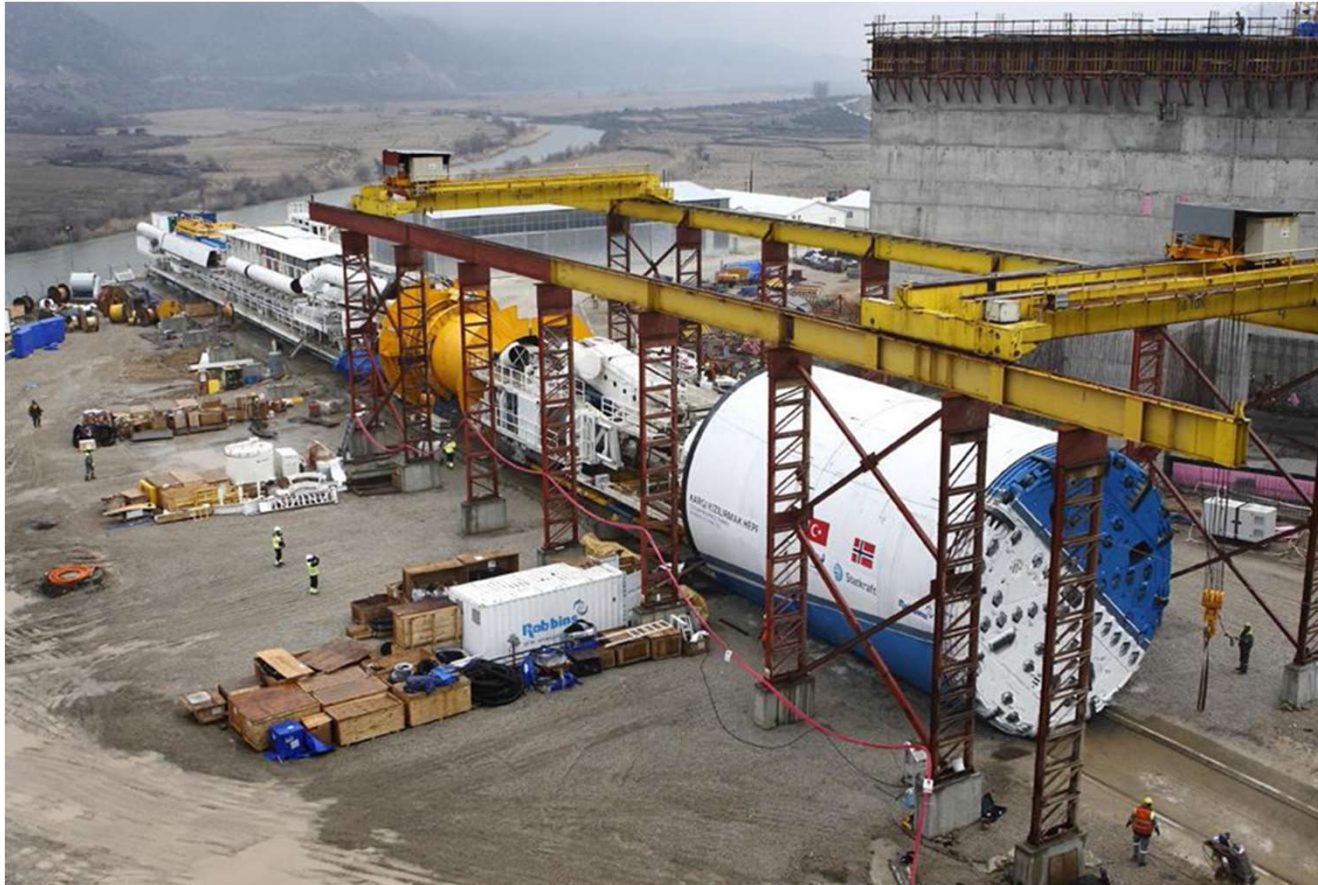
Double Shield TBM Assembled in the Field, Kargı Power Tunnel

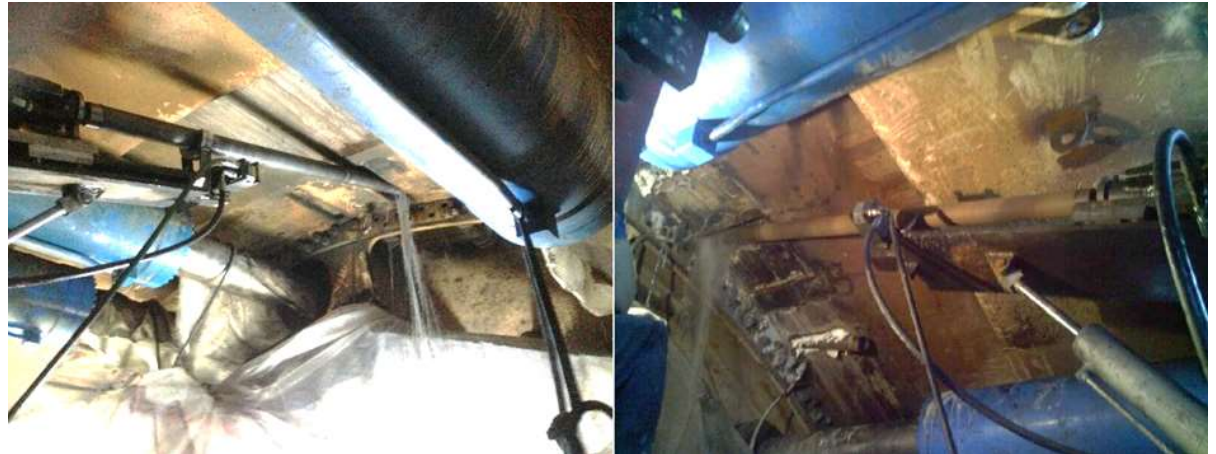
Probe Drilling in Kargı Power Tunnel

Eleven ports existed in the front shield of TBM. Drillings for UA started approximately 3 meters behind the cutter-head. Drill pipes having diameter of 3 inches were used for UA. At the beginning of the operation the holes were drilled with a drilling bit attached to drill pipes. After removing the drill bit, **a string of perforated pipes for injection,** was placed into drill hole. **Injection was done up to 120 bars pressure,** depending on injection materials properties. For injection fast setting **micro fine Portland cement (Rheocem 650)** was used. Moreover along with micro cement, **two component polyurethane injection resin (MasterRoc MP 355 and Geofom)** were also used. For filling very large voids, two component urea-silicate (MasterRoc MP 367) injection was realized. Generally 15 meters of drill holes having an approximate of 20° angle were realized with 4 meter overlaps between drills. It was seen that one umbrella arch drill, permits to support approximately 4 ring excavations, which is 6 meters in length .

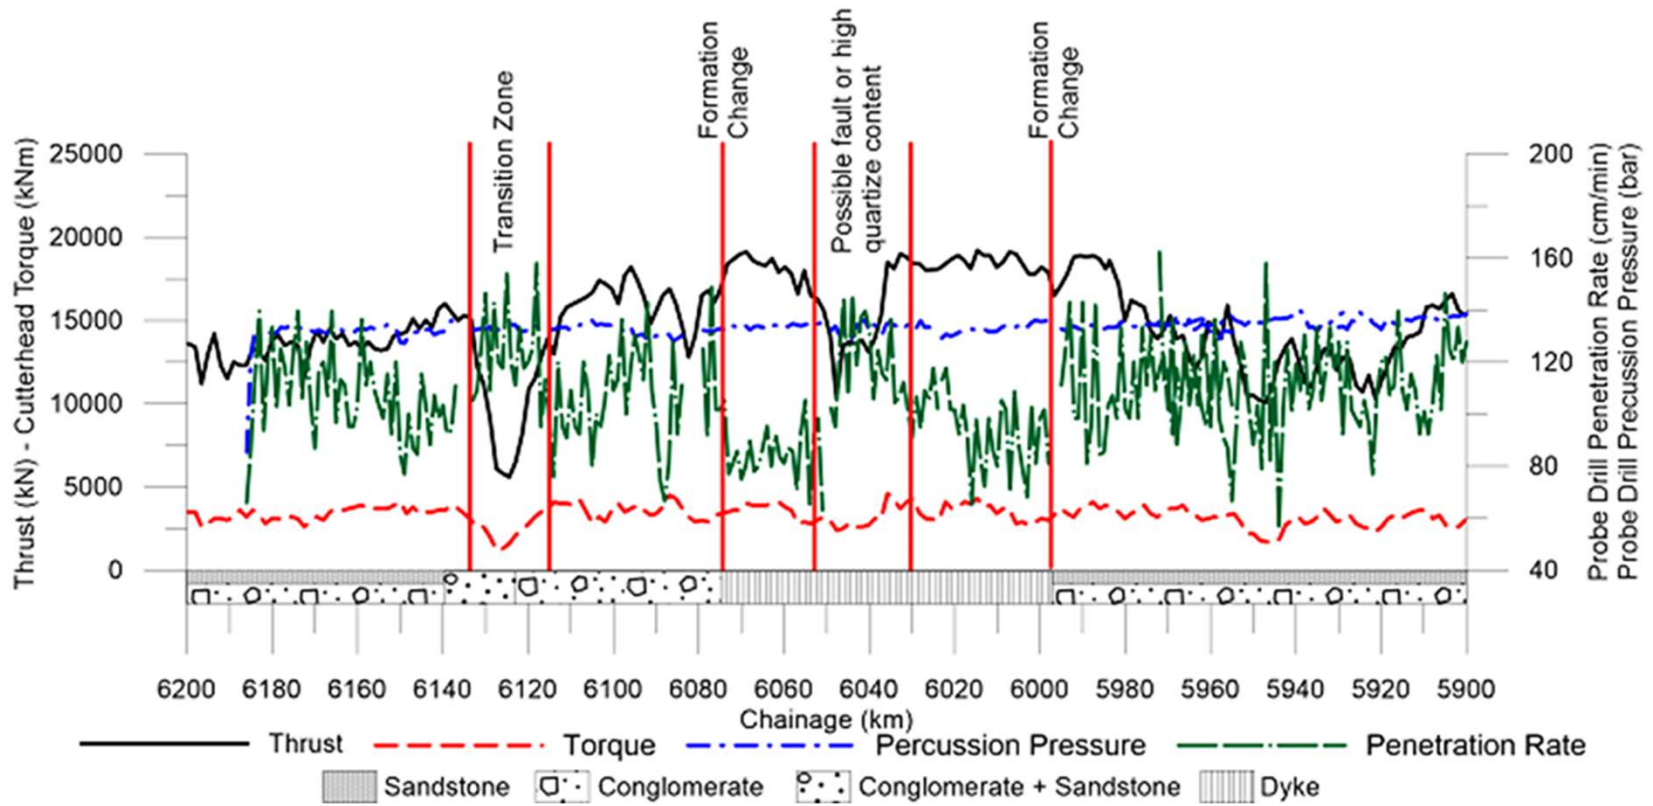
Probe Drilling In Kargı Tunnel

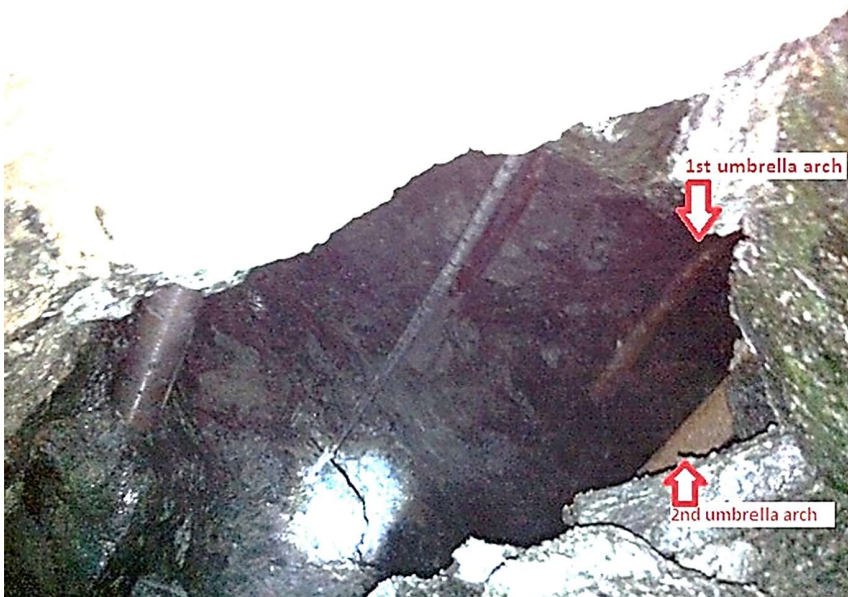
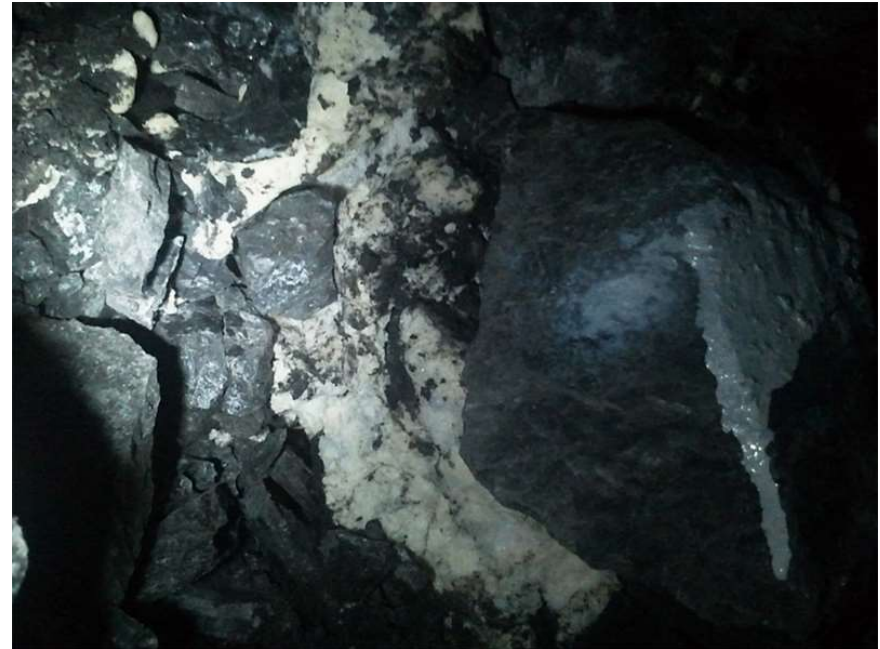
The Application of Umbrella Arch in Kargi Power Tunnel

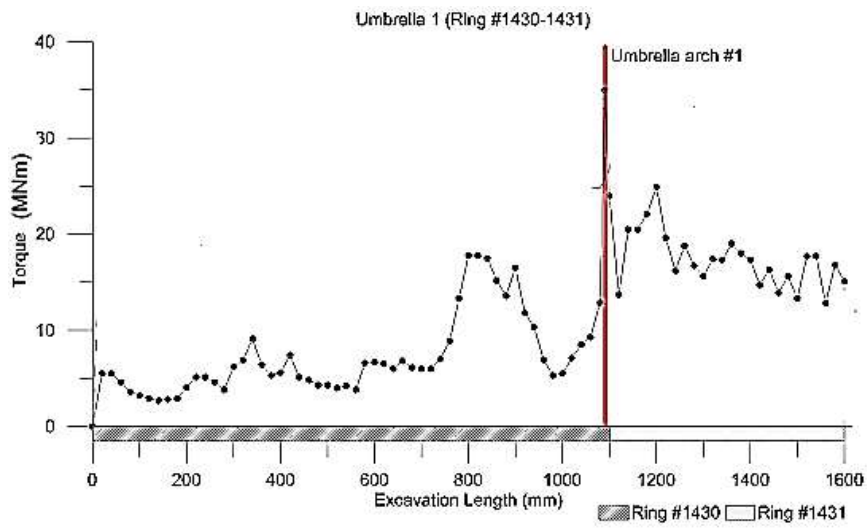
The Criteria for Umbrella Arch in Kargı Tunnel

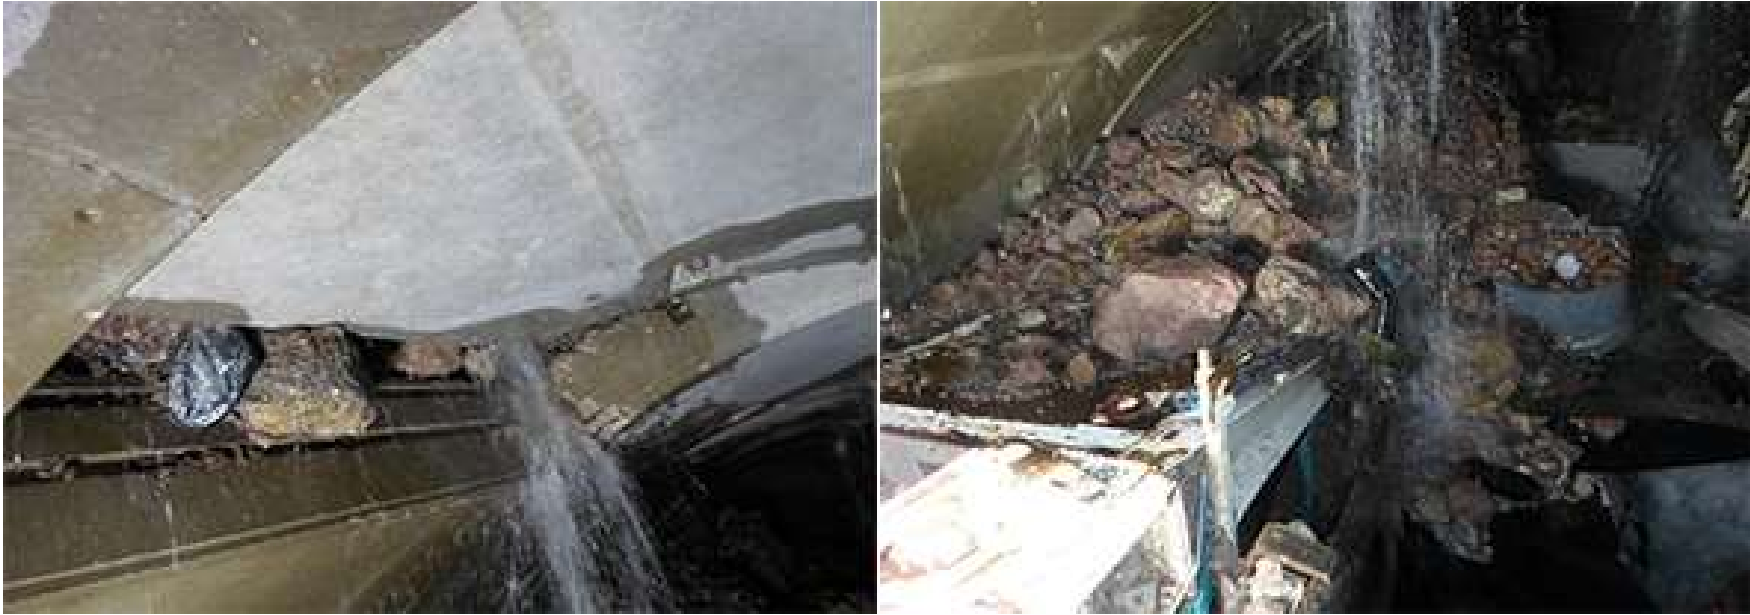
The Collapse of Third Drive the Gerede tunnel

The Machine was destroyed, the area was collapsed. A new TBM was ordered in 2015, a bypass tunnel was excavated by a new TBM
